**Flood Control Project Maintenance  
Levee Inspections**  
**LMA District Cover Sheet**  
**Spring 2017 Levee Inspection Results**

**Reclamation District No. 0784 Plumas Lake**

**Spring 2017 Levee Inspection Results**

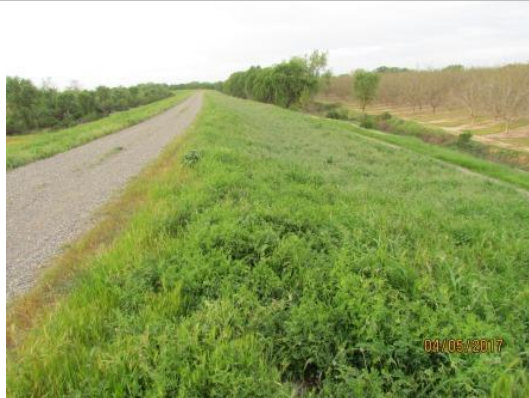
Photo 1 of 1 : SP\_2017\_RD0784\_531\_2\_20170410\_00001.jpg

LM Start	0.04	Rating **	M	Issue No.	2
LM End	2.54	Issue Type +	Ma	Location *	WS
Category	Earthen Levee			GPS Latitude/Longitude	
				Start	End
Item	Vegetation			39.125324 °	39.090307 °
				-121.588604 °	-121.584686 °
DWR ID	DWR_RD0784_02A_s_2017_2				
Comment Code					
V1 : Control annual grass and weeds on the levee slopes and easements.					
Inspector Comment					
Maintain annual grasses, Spring 2017.

View looking downstream of annual grasses, Spring 2017.

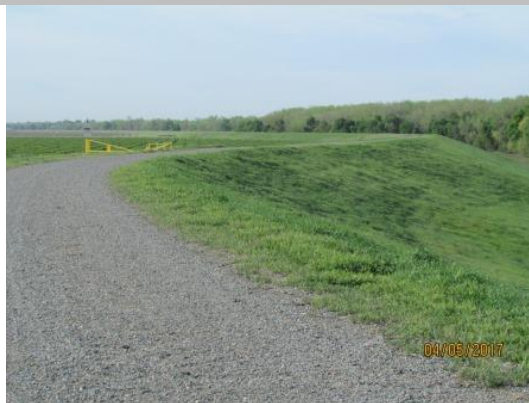
Photo 1 of 1 : SP\_2017\_RD0784\_532\_3\_20170410\_00005.jpg

LM Start	9.19	Rating **	A/W	Issue No.	3
LM End	12.86	Issue Type +	Ma	Location *	WS
Category	Earthen Levee			GPS Latitude/Longitude	
				Start	End
Item	Vegetation			39.006792 °	38.954616 °
				-121.577789 °	-121.574699 °
DWR ID	DWR_RD0784_02B_s_2017_3				
Comment Code					
V1 : Control annual grass and weeds on the levee slopes and easements.					
Inspector Comment					
Annual grasses are less than 6" tall at time of inspection, Spring 2017.

View looking downstream of annual grasses, Spring 2017.

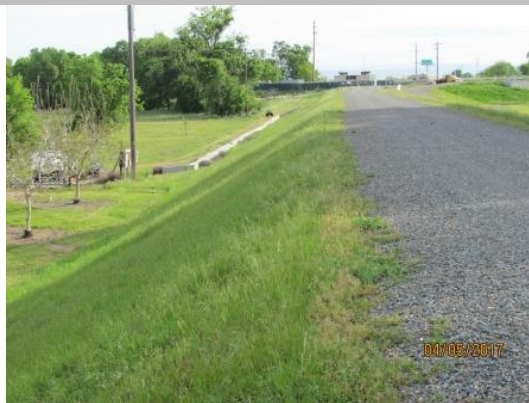
Photo 1 of 1 : SP\_2017\_RD0784\_533\_1\_20170410\_00002.jpg

LM Start	2.45	Rating **	A/W	Issue No.	1
LM End	3.20	Issue Type +	Ma	Location *	LS
Category	Earthen Levee			GPS Latitude/Longitude	
				Start	End
Item	Vegetation			38.970853 °	38.974686 °
				-121.547385 °	-121.535309 °
DWR ID	DWR_RD0784_03A_s_2017_1				
Comment Code					
V1 : Control annual grass and weeds on the levee slopes and easements.					
Inspector Comment					
Annual grasses are less than 6" tall at time of inspection, Spring 2017.

View looking upstream at annual grasses, Spring 2017.

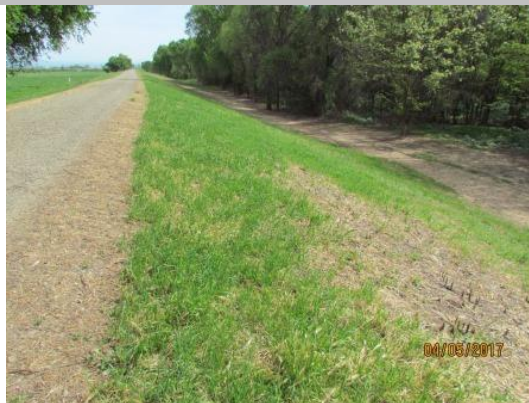
Photo 1 of 1 : SP\_2017\_RD0784\_534\_4\_20170410\_00004.jpg

LM Start	3.23	Rating **	A/W	Issue No.	4
LM End	4.69	Issue Type +	Ma	Location *	WS
Category	Earthen Levee			GPS Latitude/Longitude	
				Start	End
Item	Vegetation			38.974354 °	38.985522 °
				-121.532118 °	-121.510601 °
DWR ID	DWR_RD0784_03B_s_2017_4				
Comment Code					
V1 : Control annual grass and weeds on the levee slopes and easements.					
Inspector Comment					
Annual grasses are less than 6" tall at time of inspection, Spring 2017.

View looking upstream of well maintained annual grasses, Spring 2017.

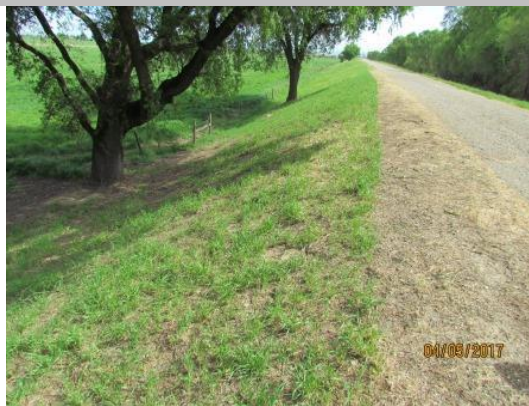
Photo 1 of 1 : SP\_2017\_RD0784\_534\_3\_20170410\_00005.jpg

LM Start	3.23	Rating **	A/W	Issue No.	3
LM End	4.69	Issue Type +	Ma	Location *	LS
Category	Earthen Levee			GPS Latitude/Longitude	
				Start	End
Item	Vegetation			38.974354 °	38.985522 °
				-121.532117 °	-121.510602 °
DWR ID	DWR_RD0784_03B_s_2017_3				
Comment Code					
V1 : Control annual grass and weeds on the levee slopes and easements.					
Inspector Comment					
Annual grasses are less than 6" tall at time of inspection, Spring 2017.

View looking upstream of well maintained annual grasses, Spring 2017.

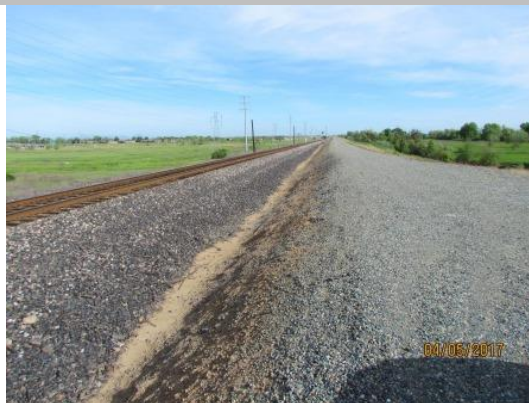
Photo 1 of 1 : SP\_2017\_RD0784\_181\_2\_20170410\_00004.jpg

LM Start	0.01	Rating **	A	Issue No.	2
LM End	2.52	Issue Type +	Ma	Location *	LS
Category	Earthen Levee			GPS Latitude/Longitude	
				Start	End
Item	Vegetation			38.974860 °	39.010938 °
				-121.535079 °	-121.541759 °
DWR ID	DWR_RD0784_04_s_2017_2				
Comment Code					
V1 : Control annual grass and weeds on the levee slopes and easements.					
Inspector Comment					
No unwanted vegetation, Spring 2017.

View looking upstream of no unwanted grasses or vegetation, Spring 2017.

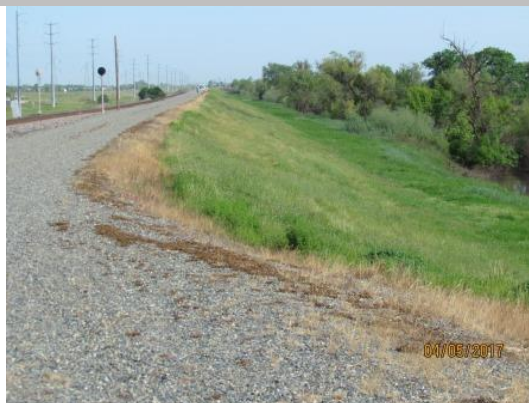
Photo 1 of 1 : SP\_2017\_RD0784\_181\_3\_20170410\_00005.jpg

LM Start	0.01	Rating **	M	Issue No.	3
LM End	6.32	Issue Type +	Ma	Location *	WS
Category	Earthen Levee			GPS Latitude/Longitude	
				Start	End
Item	Vegetation			38.974860 °	39.059299 °
				-121.535079 °	-121.551111 °
DWR ID	DWR_RD0784_04_s_2017_3				
Comment Code					
V1 : Control annual grass and weeds on the levee slopes and easements.					
Inspector Comment					
Maintain annual grasses, Spring 2017.

View looking upstream of annual grasses, Spring 2017.

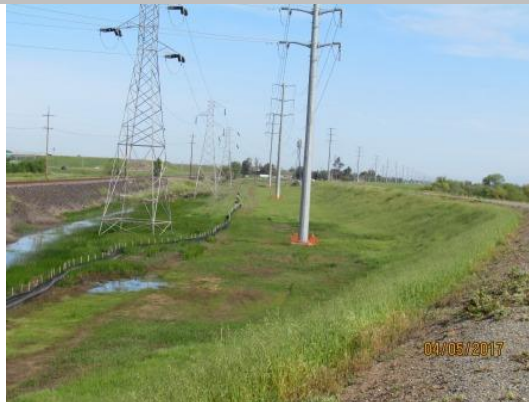
Photo 1 of 1 : SP\_2017\_RD0784\_181\_4\_20170410\_00006.jpg

LM Start	2.52	Rating **	M	Issue No.	4
LM End	6.32	Issue Type +	Ma	Location *	LS
Category	Earthen Levee			GPS Latitude/Longitude	
				Start	End
Item	Vegetation			39.010938 °	39.059298 °
				-121.541759 °	-121.551111 °
DWR ID	DWR_RD0784_04_s_2017_4				
Comment Code					
V1 : Control annual grass and weeds on the levee slopes and easements.					
Inspector Comment					
Maintain annual grasses, Spring 2017.

View looking upstream of annual grasses, Spring 2017.

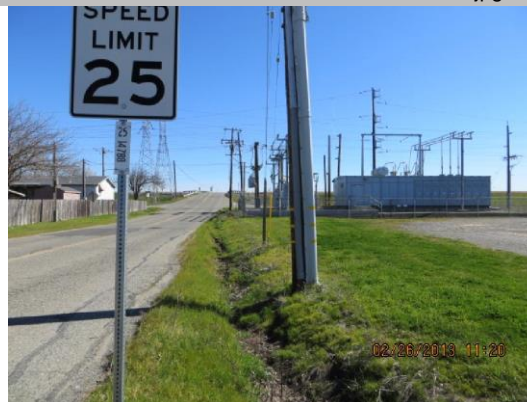
Photo 2 of 3 : UCIP\_SP\_2017\_46600\_54243.jpg

LM Start	3.59	Rating **	M	Issue No.	5
LM End	3.59	Issue Type +	En	Location *	LS
Category	Supplemental			GPS Latitude/Longitude	
				Start	End
Item	DWR UCIP Field Study			39.026347 °	39.026347 °
				-121.542343 °	-121.542343 °
DWR ID					
Comment Code					
Inspector Comment					
FS_ID:46600 DS_ID:22686 EP_NO: N/A Repair Type: Non-Urgent Crossing Status: Found UCIP Comments: No permit identified for crossing. FIELD_STRUCT_DESC: Communication line through the levee at unknown depth on downstream side of bridge. FS Date: 9/11/2015 9:25:57 AM

Communication line runs on south side of Plumas Arboga Road to JP approximately 400-feet West of levee crown.

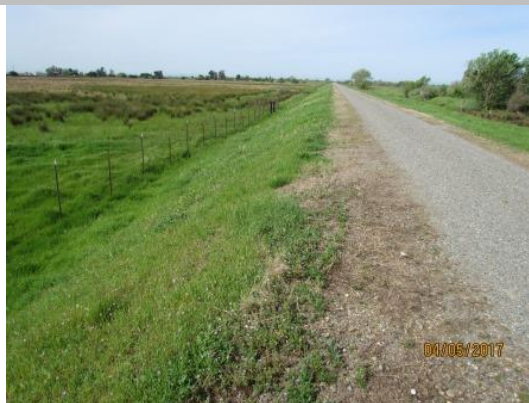
Photo 1 of 1 : SP\_2017\_RD0784\_182\_14\_20170410\_00032.jpg

LM Start	0.01	Rating **	A/W	Issue No.	14
LM End	4.19	Issue Type +	Ma	Location *	LS
Category	Earthen Levee			GPS Latitude/Longitude	
				Start	End
Item	Vegetation			38.974540 °	39.020560 °
				-121.532520 °	-121.509119 °
DWR ID	DWR_RD0784_05_s_2017_14				
Comment Code					
V1 : Control annual grass and weeds on the levee slopes and easements.					
Inspector Comment					
Annual grasses are less than 6" tall at time of inspection, Spring 2017.

View looking downstream at annual grasses, Spring 2017.

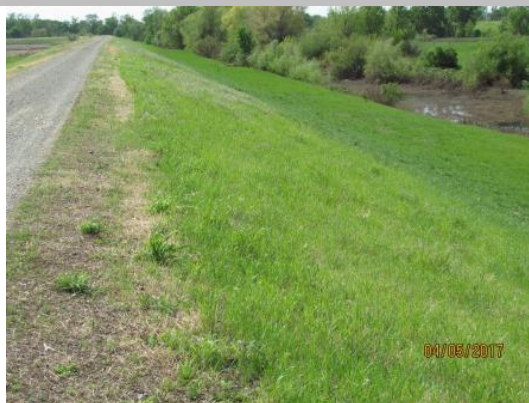
Photo 1 of 1 : SP\_2017\_RD0784\_182\_15\_20170410\_00033.jpg

LM Start	0.01	Rating **	A/W	Issue No.	15
LM End	4.19	Issue Type +	Ma	Location *	WS
Category	Earthen Levee			GPS Latitude/Longitude	
				Start	End
Item	Vegetation			38.974540 °	39.020560 °
				-121.532520 °	-121.509119 °
DWR ID	DWR_RD0784_05_s_2017_15				
Comment Code					
V1 : Control annual grass and weeds on the levee slopes and easements.					
Inspector Comment					
Annual grasses are less than 6" tall at time of inspection, Spring 2017.

View looking downstream at annual grasses, Spring 2017.

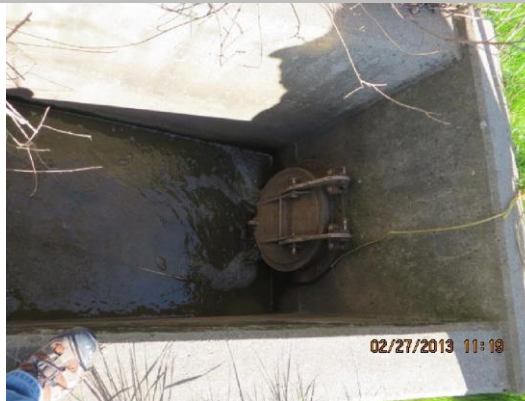
Photo 2 of 3 : UCIP\_SP\_2017\_51711\_16555.jpg

LM Start	0.12	Rating **	A/W	Issue No.	16
LM End	0.12	Issue Type +	Ma	Location *	WS
Category	Supplemental			GPS Latitude/Longitude	
				Start	End
Item	DWR UCIP LMA Responsibility			38.976147°	38.976147°
				-121.533019°	-121.533019°
DWR ID					
Comment Code					
Inspector Comment					
FS_ID:51711 DS_ID:18592 EP_NO: N/A Repair Type: No Action Needed Crossing Status: Found UCIP Comments: Good candidate for video inspection. FIELD_STRUCT_DESC: 18-inch CM drain pipe through the levee 18.0 feet below the crown. Flap gate on the waterward end. Concrete "U" headwall on the waterward end. PVC weir inlet on LS toe. Originally included in O+M manual (1955). FS Date: 2/26/2013

Concrete U-shaped outlet with flap gate on WS toe.

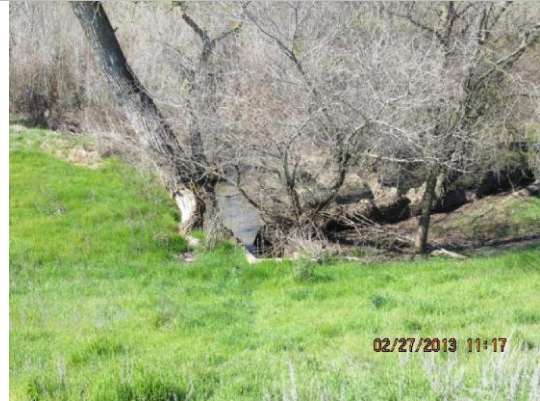
Photo 3 of 3 : UCIP\_SP\_2017\_51711\_16554.jpg

LM Start	0.12	Rating **	A/W	Issue No.	16 (cont)	
LM End	0.12	Issue Type +	Ma	Location *	WS	
Category	Supplemental			GPS Latitude/Longitude		
				Start	End	
Item	DWR UCIP LMA Responsibility			38.976147 °	38.976147 °	
				-121.533019 °	-121.533019 °	
DWR ID						
Comment Code						
Inspector Comment						
FS_ID:51711						
DS_ID:18592						
EP_NO: N/A						
Repair Type: No Action Needed						
Crossing Status: Found						
UCIP Comments: Good candidate for video inspection.						
FIELD_STRUCT_DESC: 18-inch CM drain pipe through the levee 18.0 feet below the crown. Flap gate on the waterward end. Concrete "U" headwall on the waterward end. PVC weir inlet on LS toe. Originally included in O+M manual (1955).						
FS Date: 2/26/2013

Concrete U-shaped outlet on WS toe.

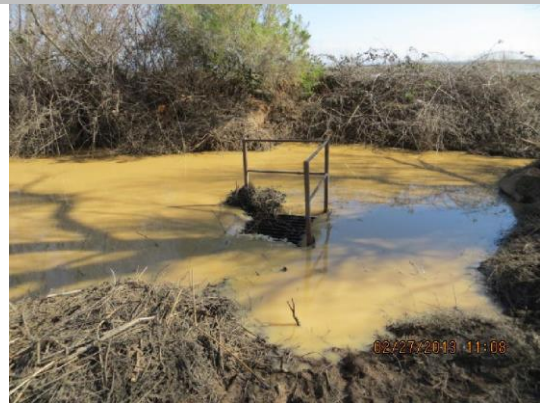
Photo 1 of 2 : UCIP\_SP\_2017\_51710\_54246.jpg

LM Start	0.84	Rating **	M	Issue No.	17
LM End	0.84	Issue Type +	Ma	Location *	WS
Category	Supplemental			GPS Latitude/Longitude	
				Start	End
Item	DWR UCIP LMA Responsibility			38.986432 °	38.986432 °
				-121.534983 °	-121.534983 °
DWR ID					
Comment Code					
Inspector Comment					
FS_ID:51710 DS_ID:18591 EP_NO: N/A Repair Type: Non-Urgent Crossing Status: Found UCIP Comments: No handle or access to slide gate on LS toe. FIELD_STRUCT_DESC: 30-inch CM pipe through the levee 23.7 feet below the crown. Flap gate on the waterward end. Slide gate in concrete drop inlet on the landward side. Originally included in O+M manual (1955). FS Date: 9/11/2015 9:05:00 AM

Concrete drop-inlet at LS toe.

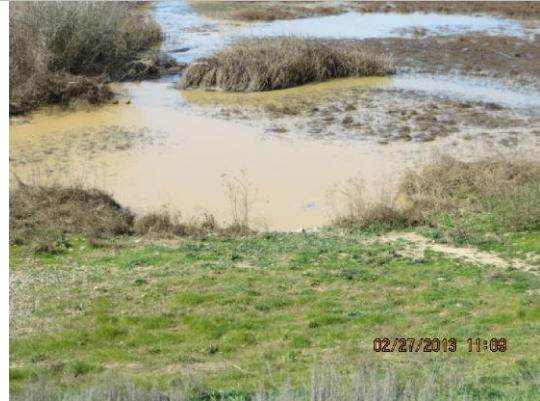
Photo 2 of 2 : UCIP\_SP\_2017\_51710\_54245.jpg

LM Start	0.84	Rating **	M	Issue No.	17 (cont)
LM End	0.84	Issue Type +	Ma	Location *	WS
Category	Supplemental			GPS Latitude/Longitude	
				Start	End
Item	DWR UCIP LMA Responsibility			38.986432 °	38.986432 °
				-121.534983 °	-121.534983 °
DWR ID					
Comment Code					
Inspector Comment					
FS_ID:51710 DS_ID:18591 EP_NO: N/A Repair Type: Non-Urgent Crossing Status: Found UCIP Comments: No handle or access to slide gate on LS toe. FIELD_STRUCT_DESC: 30-inch CM pipe through the levee 23.7 feet below the crown. Flap gate on the waterward end. Slide gate in concrete drop inlet on the landward side. Originally included in O+M manual (1955). FS Date: 9/11/2015 9:05:00 AM

Outlet with riprap on WS toe.

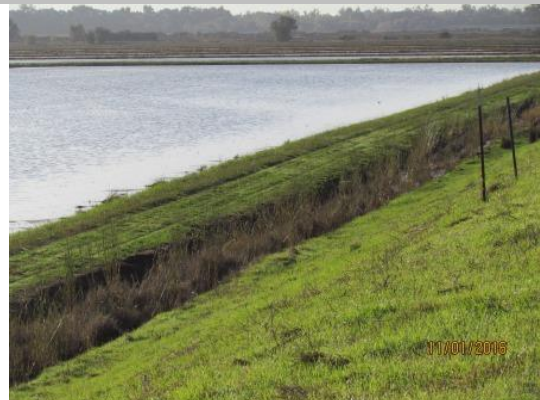
Photo 1 of 1 : SP\_2017\_RD0784\_182\_10\_20170316\_00003.jpg

LM Start	1.09	Rating **	M	Issue No.	10
LM End	1.72	Issue Type +	En	Location *	LS
Category	Earthen Levee			GPS Latitude/Longitude	
				Start	End
Item	Encroachments			38.989955 °	38.999068 °
				-121.535672 °	-121.537462 °
DWR ID	DWR_RD0784_05_s_2012_10				
Comment Code					
DT : Ditch					
Inspector Comment					
Ditch at toe of slope. Fall 2016.

View of landside looking downstream at the ditch that is along the levee toe. Fall 2016.

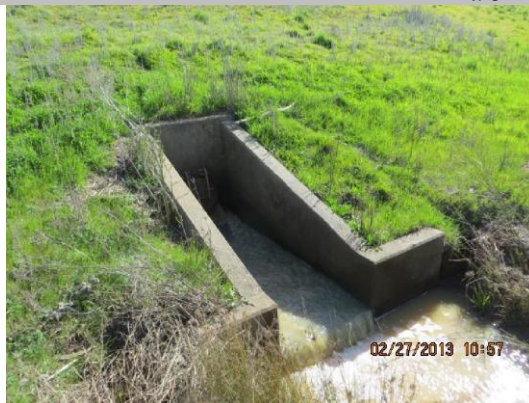
Photo 1 of 3 : UCIP\_SP\_2017\_51709\_16565.jpg

FS\_ID:51709  
DS\_ID:18590  
EP\_NO: N/A  
Repair Type: No Action Needed  
Crossing Status: Found  
UCIP Comments: Good candidate for video inspection.  
FIELD\_STRUCT\_DESC: 18-inch CM drain pipe through the levee 14.5, feet below the crown. Flap gate on the waterward end. Concrete "U" headwall on the waterward side. PVC Weir on inlet. Originally included in O+M manual (1955) See drawing 2-4-106 sheet 5..  
FS Date: 2/26/2013

Concrete U-shaped headwall and flap gate on WS toe.

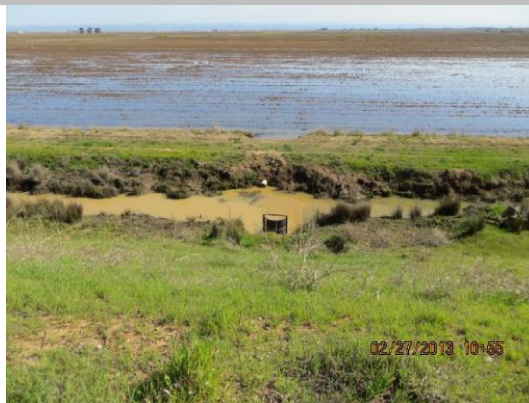
Photo 2 of 3 : UCIP\_SP\_2017\_51709\_16563.jpg

Pvc weir on inlet at LS toe.

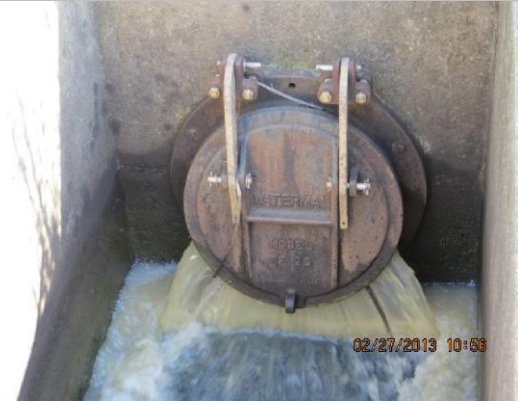
Photo 3 of 3 : UCIP\_SP\_2017\_51709\_16562.jpg

LM Start	1.60	Rating **	A/W	Issue No.	18 (cont)	
LM End	1.60	Issue Type +	Ma	Location *	LS	
Category	Supplemental			GPS Latitude/Longitude		
				Start	End	
Item	DWR UCIP LMA Responsibility			38.997305 °	38.997305 °	
				-121.537081 °	-121.537081 °	
DWR ID						
Comment Code						
Inspector Comment						
FS_ID:51709						
DS_ID:18590						
EP_NO: N/A						
Repair Type: No Action Needed						
Crossing Status: Found						
UCIP Comments: Good candidate for video inspection.						
FIELD_STRUCT_DESC: 18-inch CM drain pipe through the levee 14.5, feet below the crown. Flap gate on the waterward end. Concrete "U" headwall on the waterward side. PVC Weir on inlet. Originally included in O+M manual (1955) See drawing 2-4-106 sheet 5..						
FS Date: 2/26/2013

Concrete U-shaped headwall and flap gate on WS toe.

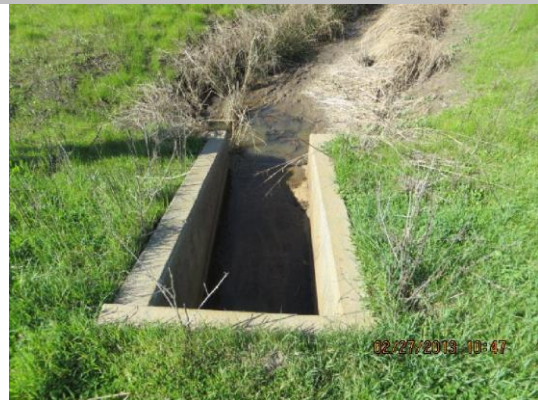
Photo 1 of 3 : UCIP\_SP\_2017\_51719\_54247.jpg

LM Start	1.86	Rating **	M	Issue No.	19
LM End	1.86	Issue Type +	Ma	Location *	LS
Category	Supplemental			GPS Latitude/Longitude	
				Start	End
Item	DWR UCIP LMA Responsibility			39.000975 °	39.000975 °
				-121.537779 °	-121.537779 °
DWR ID					
Comment Code					
Inspector Comment					
FS_ID:51719					
DS_ID:18588					
EP_NO: N/A					
Repair Type: Non-Urgent					
Crossing Status: Found					
UCIP Comments: 09/11/2015 Inlet burried. Good candidate for video inspection as pipe is corroded. (G. Wylie - FPIIB)					
FIELD_STRUCT_DESC: 18-inch CM drain pipe through the levee, 14.5 feet below the crown. Flap gate on the waterward end. Concrete "U" headwall on the waterward side. Originally included in O+M manual (1955).					
FS Date: 9/11/2015 9:36:00 AM

Concrete U-shaped outlet and flap-gate on WS toe.

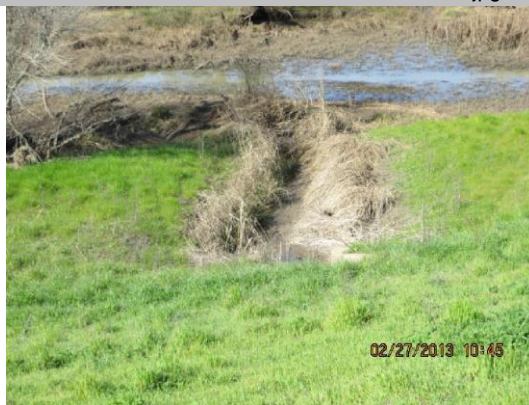
Photo 3 of 3 : UCIP\_SP\_2017\_51719\_54249.jpg

LM Start	1.86	Rating **	M	Issue No.	19 (cont)
LM End	1.86	Issue Type +	Ma	Location *	LS
Category	Supplemental			GPS Latitude/Longitude	
				Start	End
Item	DWR UCIP LMA Responsibility			39.000975 °	39.000975 °
				-121.537779 °	-121.537779 °
DWR ID					
Comment Code					
Inspector Comment					
FS_ID:51719					
DS_ID:18588					
EP_NO: N/A					
Repair Type: Non-Urgent					
Crossing Status: Found					
UCIP Comments: 09/11/2015 Inlet buried. Good candidate for video inspection as pipe is corroded. (G. Wylie - FPIIB)					
FIELD_STRUCT_DESC: 18-inch CM drain pipe through the levee, 14.5 feet below the crown. Flap gate on the waterward end. Concrete "U" headwall on the waterward side. Originally included in O+M manual (1955).					
FS Date: 9/11/2015 9:36:00 AM

Drainage outlet on WS toe.

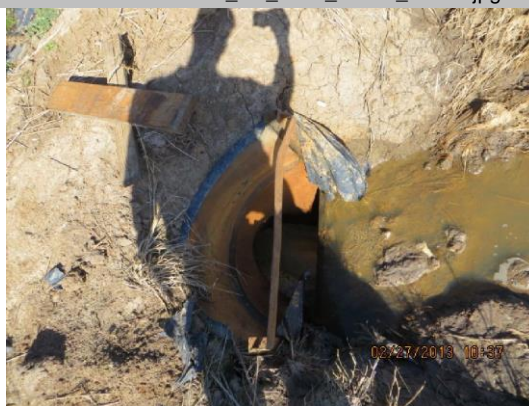
Photo 1 of 3 : UCIP\_SP\_2017\_51707\_54250.jpg

Comment Code					
Inspector Comment					
FS_ID:51707 DS_ID:18587 EP_NO: N/A Repair Type: Non-Urgent Crossing Status: Found UCIP Comments: On 1/31/2017 The waterside excess pipe end was discovered to be floating to the surface due to landside water runoff through the pipe. Because of the floating pipe, the water was not draining all the way through the pipe. Instead, the water was overtopping the levee shelf area. In order to resolve this issue, the excess portion of the pipe was cut off. After doing so, the water immediately started draining properly again. (P. Meagher, RD784 2/3/2017). Erosion at outlet may or may not be an issue. FIELD_STRUCT_DESC: 18-inch CM drain pipe through the levee, 14.5 feet below the crown. Flap gate on the waterward end. Concrete "U" headwall on the waterward side. PVC weir on inlet. Originally included in O+M manual (1955). FS Date: 2/3/2017

Inlet with PVC weir on LS toe.

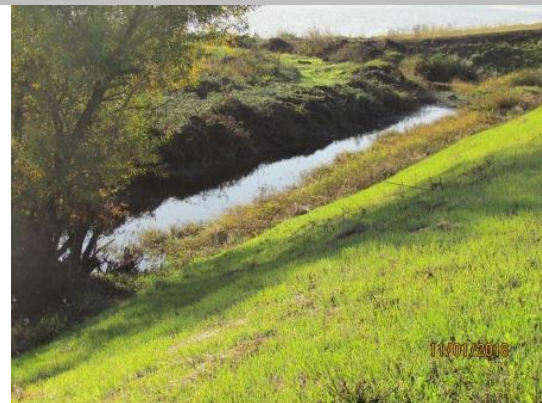
Photo 1 of 1 : SP\_2017\_RD0784\_182\_9\_20170316\_00002.jpg

LM Start	2.11	Rating **	M	Issue No.	9
LM End	3.07	Issue Type +	En	Location *	LS
Category	Earthen Levee			GPS Latitude/Longitude	
				Start	End
Item	Encroachments			39.004562 °	39.015593 °
				-121.538482 °	-121.528533 °
DWR ID	DWR_RD0784_05_s_2012_9				
Comment Code					
DT : Ditch					
Inspector Comment					
Ditch at toe of slope. Fall 2016.

View of landside looking downstream at the ditch that is along the levee toe. Fall 2016.

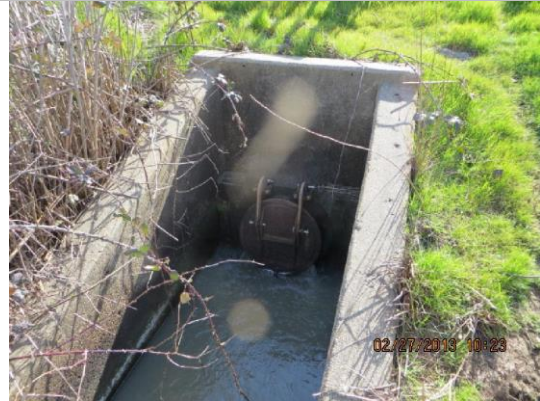
Photo 1 of 3 : UCIP\_SP\_2017\_51715\_54258.jpg

2/27/2013 - Heavy erosion around inlet headwall due to beaver activity. (W. Wylie/UCIP)  
FIELD\_STRUCT\_DESC: 18-inch corrugated metal drainage pipe through the levee, 15.5 feet below the crown. Flap gate on the waterside (WS) toe. Concrete "U" headwall located at the WS toe. (removable standpipe and bulkheads approved under Permit No. 9230, 1974 - Frach, Inc.). [Additional Reference(s): DWR Levee Logs, 2005. USACE Sacramento O&M Manual 145, August 1955 (Station 13+72). USACE As-built Drawings 2-4-106, Sheet 6, July 1944 (Station 13+72)].  
FS Date: 12/15/2016 3:36:00 PM

Concrete U-shaped headwall and flap gate on WS toe.

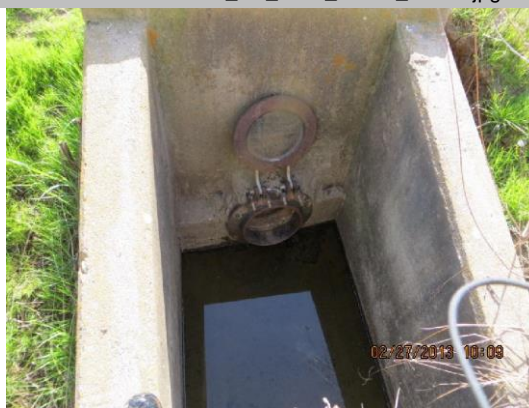
Photo 1 of 3 : UCIP\_SP\_2017\_51714\_54259.jpg

LM Start	3.06	Rating **	M	Issue No.	22
LM End	3.06	Issue Type +	Ma	Location *	LS
Category	Supplemental			GPS Latitude/Longitude	
				Start	End
Item	DWR UCIP LMA Responsibility			39.015549 °	39.015549 °
				-121.528590 °	-121.528590 °
DWR ID					
Comment Code					
Inspector Comment					
FS_ID:51714 DS_ID:18596 EP_NO: N/A Repair Type: Non-Urgent Crossing Status: Found UCIP Comments: Pipe has been sliplined with PVC, but the liner appears to be eroding at outlet and may be disjointed internal to the levee. See pic. Good candidate for video inspection. FIELD_STRUCT_DESC: 12-inch CM drain pipe through the levee, 12.0 feet below the crown. Flap gate and concrete "U" headwall on the waterward side. PVC weir on inlet at LS toe. Originally included in O+M manual (1955). FS Date: 9/11/2015 9:26:00 AM

Concrete U-shaped headwall and flap gate on WS toe.

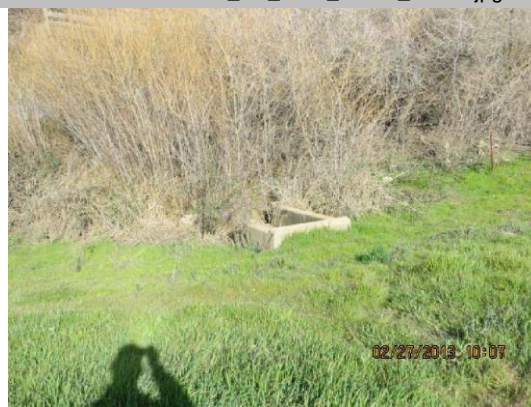
Photo 3 of 3 : UCIP\_SP\_2017\_51714\_54261.jpg

Concrete U-shaped headwall on WS toe.

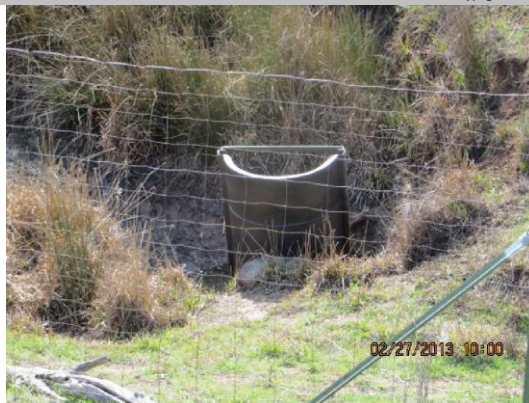
Photo 1 of 2 : UCIP\_SP\_2017\_9566\_16594.jpg

LM Start	3.23	Rating **	A/W	Issue No.	23
LM End	3.23	Issue Type +	Ma	Location *	LS
Category	Supplemental			GPS Latitude/Longitude	
				Start	End
Item	DWR UCIP LMA Responsibility			39.017336 °	39.017336 °
				-121.526530 °	-121.526530 °
DWR ID					
Comment Code					
Inspector Comment					
FS_ID:9566 DS_ID:18595 EP_NO: N/A Repair Type: No Action Needed Crossing Status: Found UCIP Comments: Good candidate for video inspection. FIELD_STRUCT_DESC: 18-inch CM drain pipe through the levee, 15.8 feet below the crown. Flap gate on the waterward end. PVC weir on inlet at LS toe. Originally included in O+M manual (1955). See Drawing 2-4-106 Sheet 6. FS Date: 2/27/2013

PVC weir inlet on LS toe.

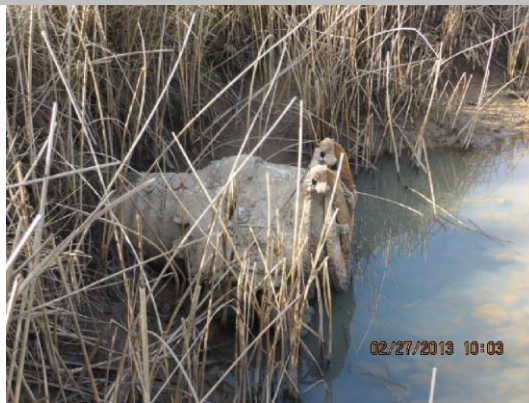
Photo 2 of 2 : UCIP\_SP\_2017\_9566\_16593.jpg

Flap gate at WS toe.

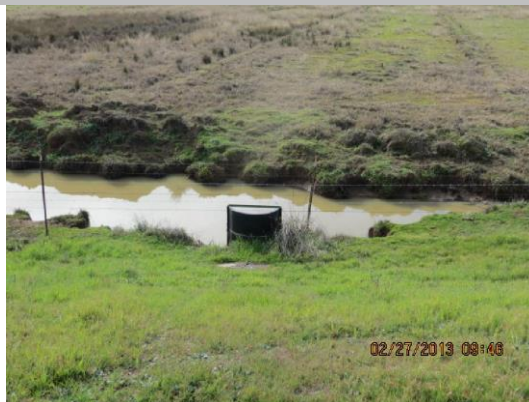
Photo 2 of 3 : UCIP\_SP\_2017\_51713\_16591.jpg

LM Start	3.79	Rating **	A/W	Issue No.	24
LM End	3.79	Issue Type +	Ma	Location *	LS
Category	Supplemental			GPS Latitude/Longitude	
				Start	End
Item	DWR UCIP LMA Responsibility			39.019222 °	39.019222 °
				-121.516414 °	-121.516414 °
DWR ID					
Comment Code					
Inspector Comment					
FS_ID:51713 DS_ID:18594 EP_NO: N/A Repair Type: No Action Needed Crossing Status: Found UCIP Comments: FIELD_STRUCT_DESC: 18-inch CM drain pipe through the levee, 8.8 feet below the crown. Flap gate and headwall on the waterward end. Originally included in O+M manual (1955). FS Date: 2/27/2013

PVC weir at inlet on LS toe.

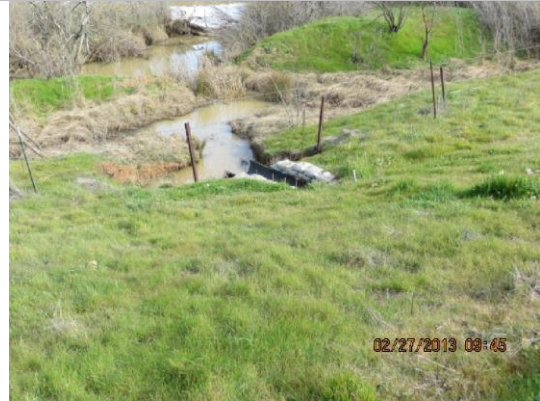
Photo 3 of 3 : UCIP\_SP\_2017\_51713\_16592.jpg

Concrete outlet on WS toe.

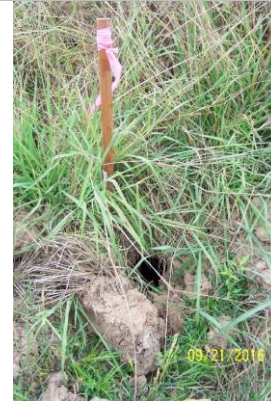
Photo 2 of 3 : UCIP\_SP\_2017\_51712\_76148.jpg

Comment Code					
Inspector Comment					
FS_ID:51712 DS_ID:18593 EP_NO: N/A Repair Type: Non-Urgent Crossing Status: Found UCIP Comments: 11/14/2016 - Photos added of exposed flap gate on WS and possible inlet location on LS. Condition remains as Non-Urgent because of inlet not being fully operable. Unknown if pipe will operate as designed during high water or if it is full of sediment.11/01/2015 - Waterside Flap Gate Uncovered. Photo sent to DWR Matt Hoffman on 3/3/2014. Fresh photo sent to DWR Pavel Kazi on 9/9/2015. Landside toe has never been able to be located. Requesting DWR inspector to change the status of this issue to "No Action Needed". (P.Meagher - RD784).Pipe buried on LS toe and flap gate is blocked by soil on WS toe. (W. Wylie - UCIP Inspector). FIELD_STRUCT_DESC: 18-inch CM pipe through the levee, 10.0 feet below the crown. Flap gate on the waterward end. Originally included in O+M manual (1955). FS Date: 10/9/2015

Possible location of the inlet on the LS toe

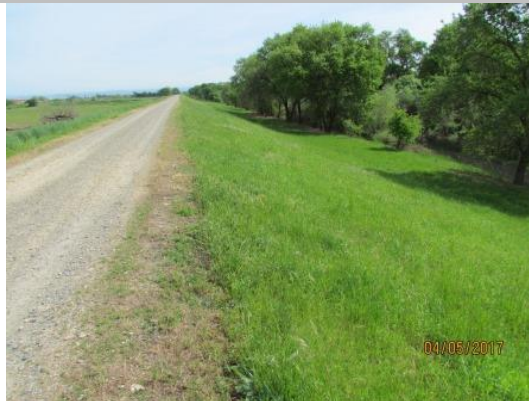
Photo 1 of 1 : SP\_2017\_RD0784\_183\_3\_20170410\_00004.jpg

LM Start	0.00	Rating **	M	Issue No.	3
LM End	0.25	Issue Type +	Ma	Location *	WS
Category	Earthen Levee			GPS Latitude/Longitude	
				Start	End
Item	Vegetation			38.985575 °	38.987580 °
				-121.510497 °	-121.506665 °
DWR ID	DWR_RD0784_06_s_2017_3				
Comment Code					
V1 : Control annual grass and weeds on the levee slopes and easements.					
Inspector Comment					
Maintain annual grasses, Spring 2017.

View looking upstream of annual grasses, Spring 2017.

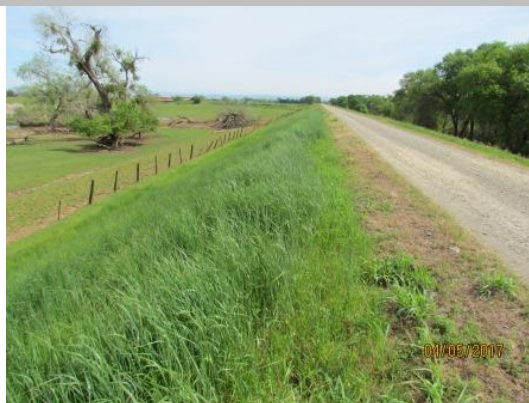
Photo 1 of 1 : SP\_2017\_RD0784\_183\_2\_20170410\_00005.jpg

LM Start	0.00	Rating **	M	Issue No.	2
LM End	0.25	Issue Type +	Ma	Location *	LS
Category	Earthen Levee			GPS Latitude/Longitude	
				Start	End
Item	Vegetation			38.985575 °	38.987580 °
				-121.510497 °	-121.506664 °
DWR ID	DWR_RD0784_06_s_2017_2				
Comment Code					
V1 : Control annual grass and weeds on the levee slopes and easements.					
Inspector Comment					
Maintain annual grasses, Spring 2017.

View looking upstream of annual grasses, Spring 2017.

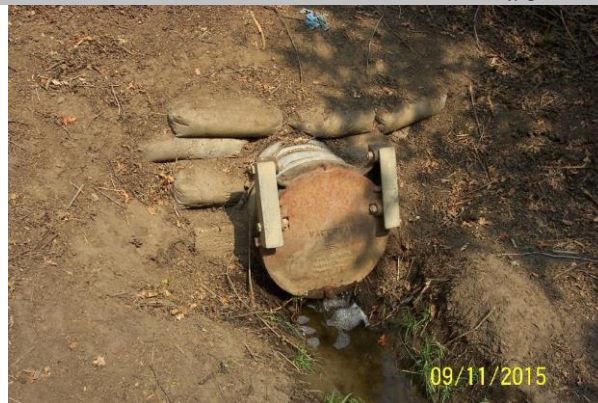
Photo 1 of 3 : UCIP\_SP\_2017\_51716\_74682.jpg

LM Start	0.06	Rating **	M	Issue No.	4
LM End	0.06	Issue Type +	Ma	Location *	LS
Category	Supplemental			GPS Latitude/Longitude	
				Start	End
Item	DWR UCIP LMA Responsibility			38.985999 °	38.985999 °
				-121.509618 °	-121.509618 °
DWR ID					
Comment Code					
Inspector Comment					
FS_ID:51716					
DS_ID:18626					
EP_NO: N/A					
Repair Type: Non-Urgent					
Crossing Status: Found					
UCIP Comments: 10-30-2015 - Waterside flap gate was cleared in December 2014 and again in September 2015 No LMA access available on Landside (P. Meagher).Pipe partially blocked on LS and flap gate blocked on WS (W. Wylie-UCIP Inspector)					
FIELD_STRUCT_DESC: 18-inch CM drain pipe through the levee 19-feet below the crown. Gate valve on waterward side. Originally included in O+M Manual (1955). See Dwg. 2-4-106 Sheet 2.					
FS Date: 9/11/2015

Flap Gate is clear as of 9/11/15.

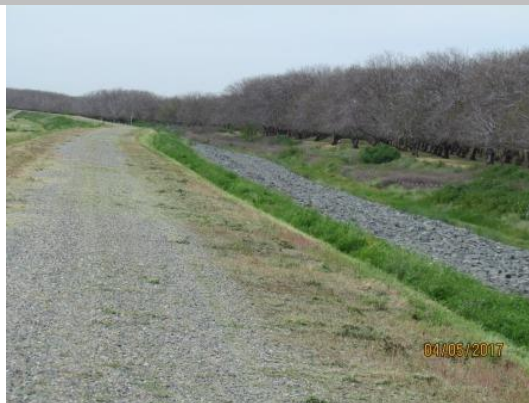
Photo 1 of 1 : SP\_2017\_RD0784\_184\_2\_20170410\_00001.jpg

LM Start	0.12	Rating **	M	Issue No.	2
LM End	3.81	Issue Type +	Ma	Location *	WS
Category	Earthen Levee			GPS Latitude/Longitude	
				Start	End
Item	Vegetation			39.135132 °	39.165534 °
				-121.550156 °	-121.495582 °
DWR ID	DWR_RD0784_07_s_2017_2				
Comment Code					
V1 : Control annual grass and weeds on the levee slopes and easements.					
Inspector Comment					
Shoulders of crown are mowed, maintained annual grasses on slopes, Spring 2017.

View looking downstream of annual grasses, Spring 2017.

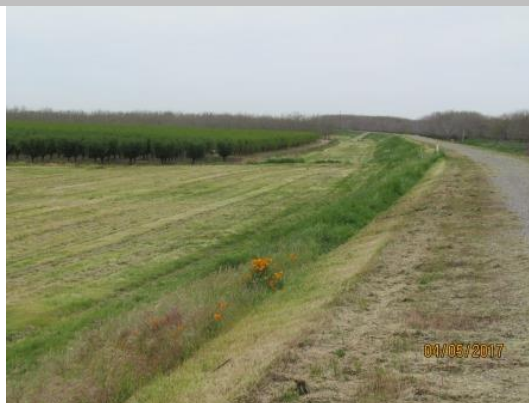
Photo 1 of 1 : SP\_2017\_RD0784\_184\_1\_20170410\_00002.jpg

LM Start	0.12	Rating **	M	Issue No.	1
LM End	3.81	Issue Type +	Ma	Location *	LS
Category	Earthen Levee			GPS Latitude/Longitude	
				Start	End
Item	Vegetation			39.135133 °	39.165534 °
				-121.550156 °	-121.495582 °
DWR ID	DWR_RD0784_07_s_2017_1				
Comment Code					
V1 : Control annual grass and weeds on the levee slopes and easements.					
Inspector Comment					
Shoulders of crown are mowed, maintained annual grasses on slopes, Spring 2017.

View looking downstream of annual grasses, Spring 2017.

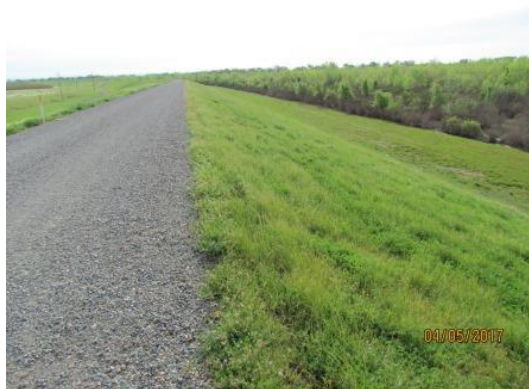
Photo 1 of 1 : SP\_2017\_RD0784\_437\_2\_20170410\_00001.jpg

LM Start	0.06	Rating **	M	Issue No.	2
LM End	1.92	Issue Type +	Ma	Location *	WS
Category	Earthen Levee			GPS Latitude/Longitude	
				Start	End
Item	Vegetation			38.955510 °	38.970527 °
				-121.573814 °	-121.547607 °
DWR ID	DWR_RD0784_08_s_2017_2				
Comment Code					
V1 : Control annual grass and weeds on the levee slopes and easements.					
Inspector Comment					
Maintain annual grasses, Spring 2017.

View looking upstream of annual grasses, Spring 2017.

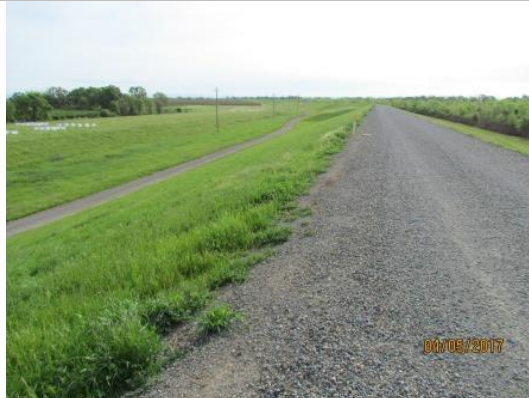
Photo 1 of 1 : SP\_2017\_RD0784\_437\_1\_20170410\_00002.jpg

LM Start	0.06	Rating **	M	Issue No.	1
LM End	1.92	Issue Type +	Ma	Location *	LS
Category	Earthen Levee			GPS Latitude/Longitude	
				Start	End
Item	Vegetation			38.955509 °	38.970526 °
				-121.573814 °	-121.547607 °
DWR ID	DWR_RD0784_08_s_2017_1				
Comment Code					
V1 : Control annual grass and weeds on the levee slopes and easements.					
Inspector Comment					
Maintain annual grasses, Spring 2017.

View looking upstream of annual grasses, Spring 2017.

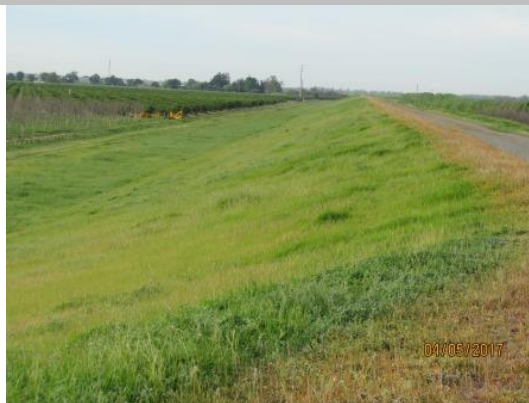
Photo 1 of 1 : SP\_2017\_RD0784\_530\_3\_20170410\_00006.jpg

LM Start	0.01	Rating **	A/W	Issue No.	3
LM End	5.71	Issue Type +	Ma	Location *	LS
Category	Earthen Levee			GPS Latitude/Longitude	
				Start	End
Item	Vegetation			39.090139 °	39.010081 °
				-121.584769 °	-121.579371 °
DWR ID	DWR_RD0784_09_s_2017_3				
Comment Code					
V1 : Control annual grass and weeds on the levee slopes and easements.					
Inspector Comment					
Annual grasses are less than 6" tall at time of inspection, Spring 2017.

View looking downstream of annual grasses, Spring 2017.

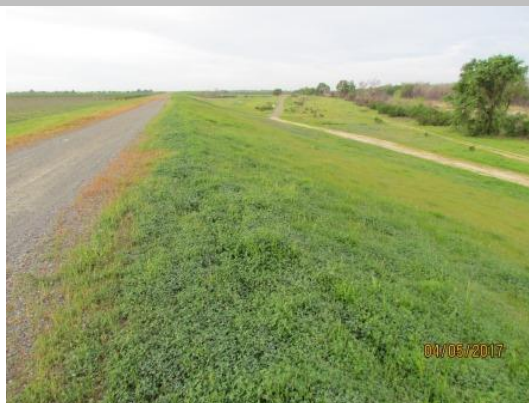
Photo 1 of 1 : SP\_2017\_RD0784\_530\_4\_20170410\_00005.jpg

LM Start	0.01	Rating **	A/W	Issue No.	4
LM End	5.71	Issue Type +	Ma	Location *	WS
Category	Earthen Levee			GPS Latitude/Longitude	
				Start	End
Item	Vegetation			39.090139 °	39.010081 °
				-121.584769 °	-121.579371 °
DWR ID	DWR_RD0784_09_s_2017_4				
Comment Code					
V1 : Control annual grass and weeds on the levee slopes and easements.					
Inspector Comment					
Annual grasses are less than 6" tall at time of inspection, Spring 2017.

View looking downstream of annual vegetation, Spring 2017.

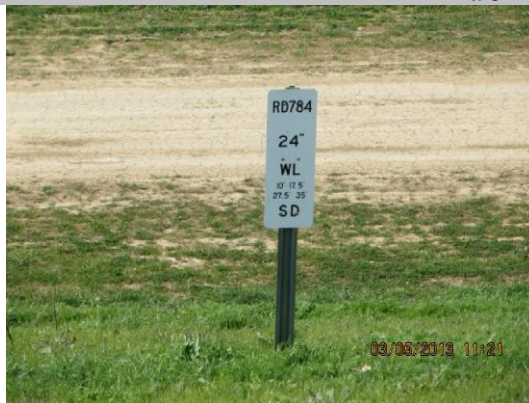
Photo 1 of 2 : UCIP\_SP\_2017\_46591\_27163.jpg

FS\_ID:46591  
DS\_ID:23976  
EP\_NO: N/A  
Repair Type: Non-Urgent  
Crossing Status: Indicator Found  
UCIP Comments: Need to determine Permit for crossing.  
FIELD\_STRUCT\_DESC: 24-inch storm drain discharge pipe through the levee at unknown depth below the crown. Pumping plant on Landward toe. Pump Station No. 3. Paddle markers on both WS toe and LS toe at pumping plant fence.  
FS Date: 9/11/2015 9:04:50 AM

Paddle marker on WS toe.

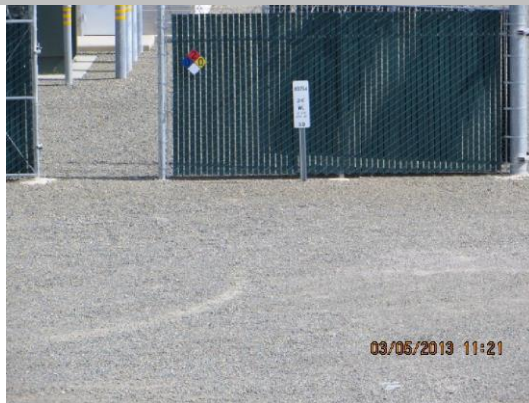
Photo 2 of 2 : UCIP\_SP\_2017\_46591\_27162.jpg

Paddle marker on LS toe at pumping plant fence.

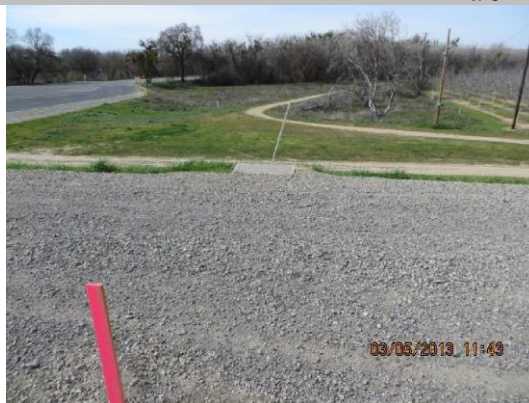
Photo 1 of 2 : UCIP\_SP\_2017\_46586\_27161.jpg

FS\_ID:46586  
DS\_ID:23996  
EP\_NO: N/A  
Repair Type: Non-Urgent  
Crossing Status: Found  
UCIP Comments: Need to determine Permit for Crossing.  
FIELD\_STRUCT\_DESC: 2-Christy boxes. One on either side of crown.  
Likely an electrical or other small conduit crossing.  
FS Date: 9/11/2015 9:00:50 AM

Christy box on WS shoulder.

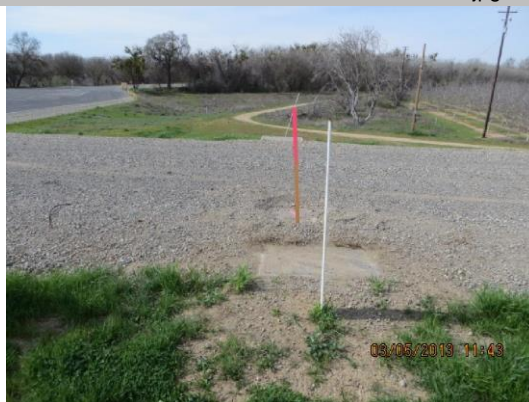
Photo 2 of 2 : UCIP\_SP\_2017\_46586\_27160.jpg

Christy box on LS shoulder.
